Hanna Smoleńska<sup>1</sup>, Włodzimierz Kończewicz<sup>2</sup>

## **The impact of material selection on mechanical properties and durability of exhaust valve faces of a ship engine, after operation in real conditions**

Valves with faces covered with layers have been installed in the engine on the ship “Dar Młodzieży”. AL 20/24 engine has the following parameters: in-line engine, 8-cylinders; cylinder diameter 200 mm; piston stroke 240 mm; swept capacity 7540 cm<sup>3</sup>; nominal rotational speed 720/750 rev/min or 900/1000 rev/min; 136kW/Cyl.

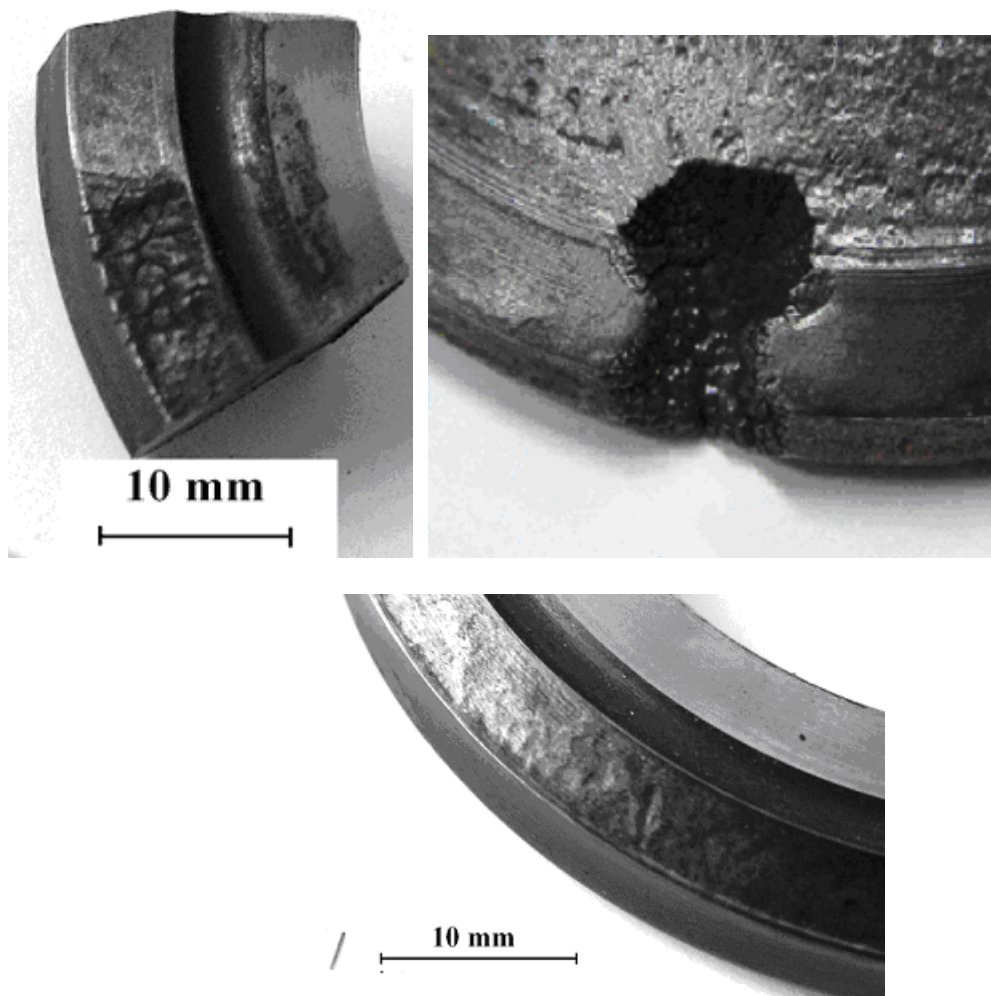
- loss of tightness caused by corrosion pits because of erosive exhaust fumes (Fig. 1b),
- over burning of the valve head edges caused by the flow of extremely hot gases through leaks (Fig. 1a),
- cracks, scratches and splinters caused by fatigue of the face layer (Fig. 1c).

*Fig. 1. Examples of damaged exhaust valve of the marine engine: a) - corrosion of the face - "pavement", b) - destruction of the face and substrate due to valve leaks - irreparable; c) - face wear – repairable*

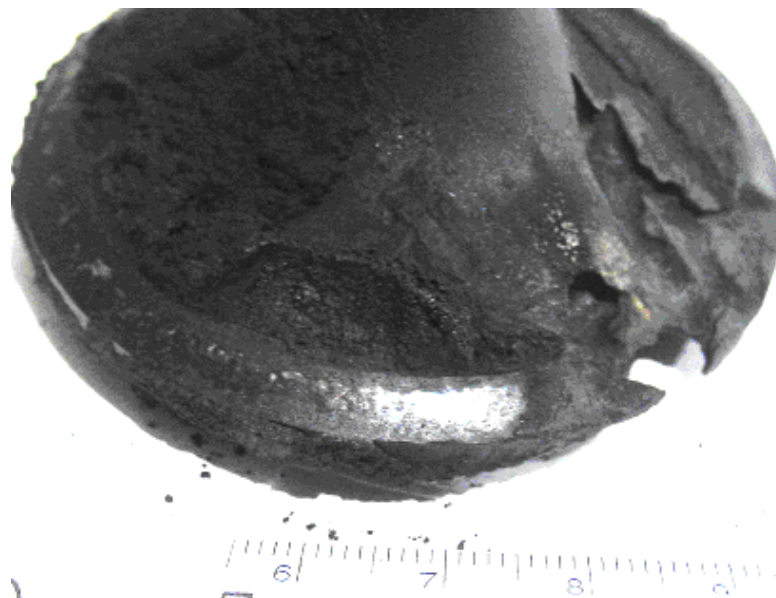
During operation, it turned out that after 2000 hours of service, the N valve was completely destroyed.

*Fig. 2. N valve after 2000 hours of operation*

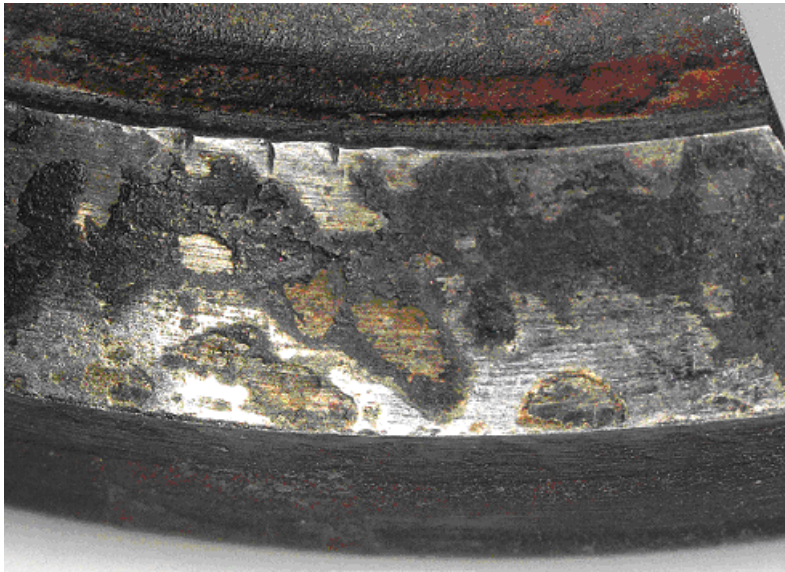
The L12 valve after 3000 hours of operation did not show any significant signs of wear or damage.

*Fig.3. L12 valve after 3000 hours of operation. Magnification 10x*

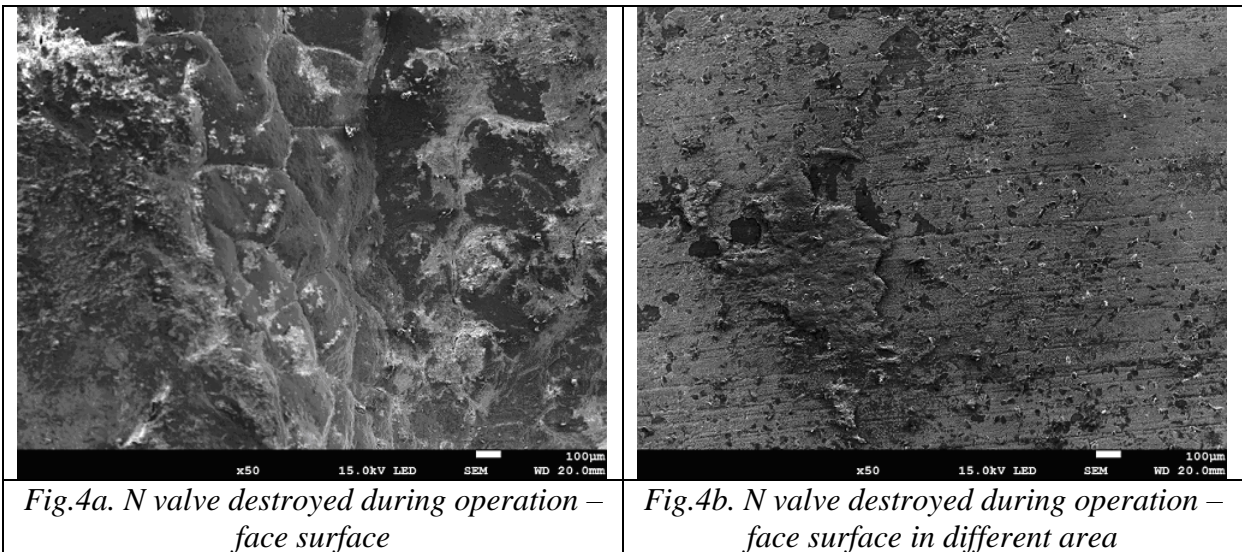
A scanning electron microscope (SEM) was used for metallographic examinations which allowed the analysis of the valve face surfaces and microstructures on the cross-sections perpendicular to the face surface. Fig. 4 shows the surface condition of the N valve after service. Significant differences of the appearance of the valve face surface were observed. It also indicates different properties of the material in different area of the face which is not accessible.

*Fig.4a. N valve destroyed during operation – face surface*

*Fig.4b. N valve destroyed during operation – face surface in different area*

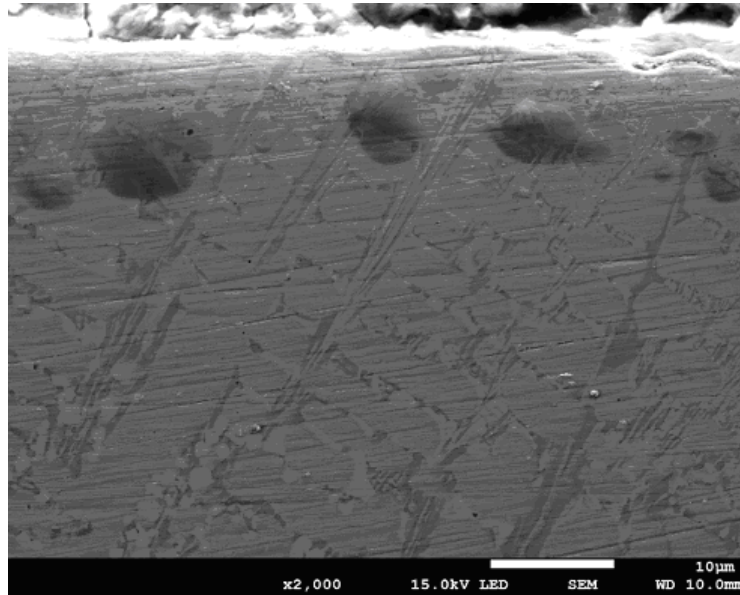
*Fig.5. N valve destroyed during operation. Microstructure on the cross-section, close to the face surface*

SEM-EDAX analysis in the cross-section, near the surface of the destroyed valve showed the presence of a dendritic structure with numerous precipitates characterized by a high content of molybdenum, nickel and chromium. Possible Phase P.

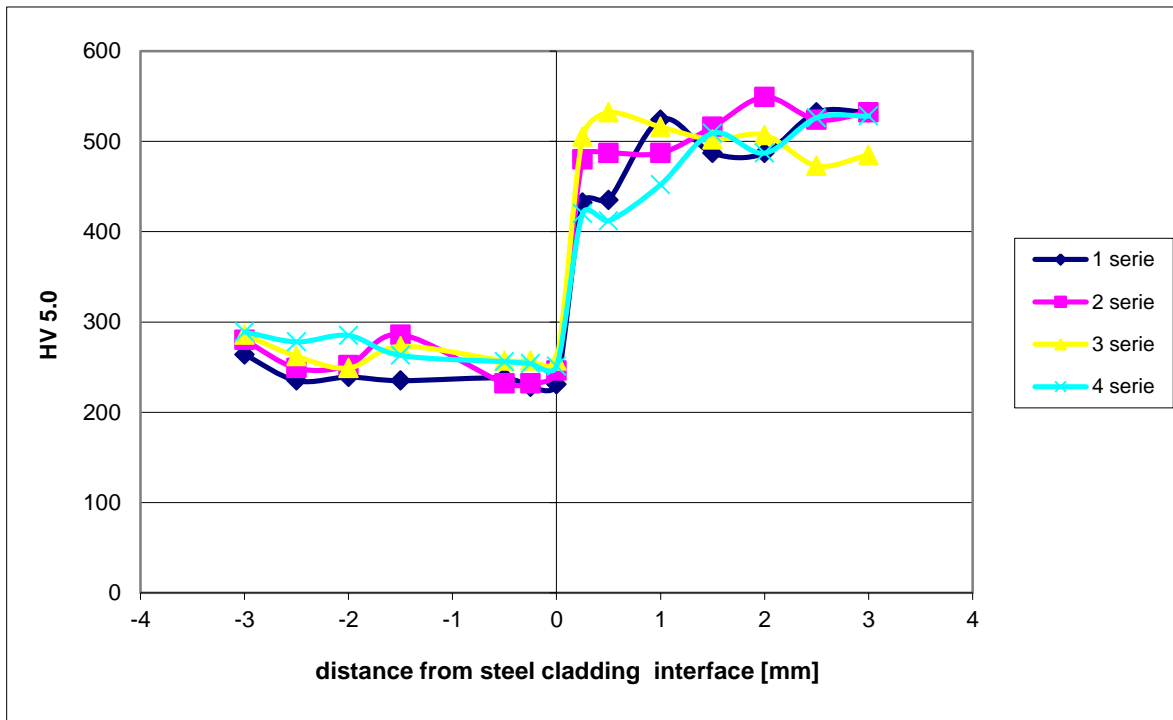
Fig.9. Results of HV5 hardness measurements for face cladding and steel base of L12 valve after 3000 hours operation - 4 series

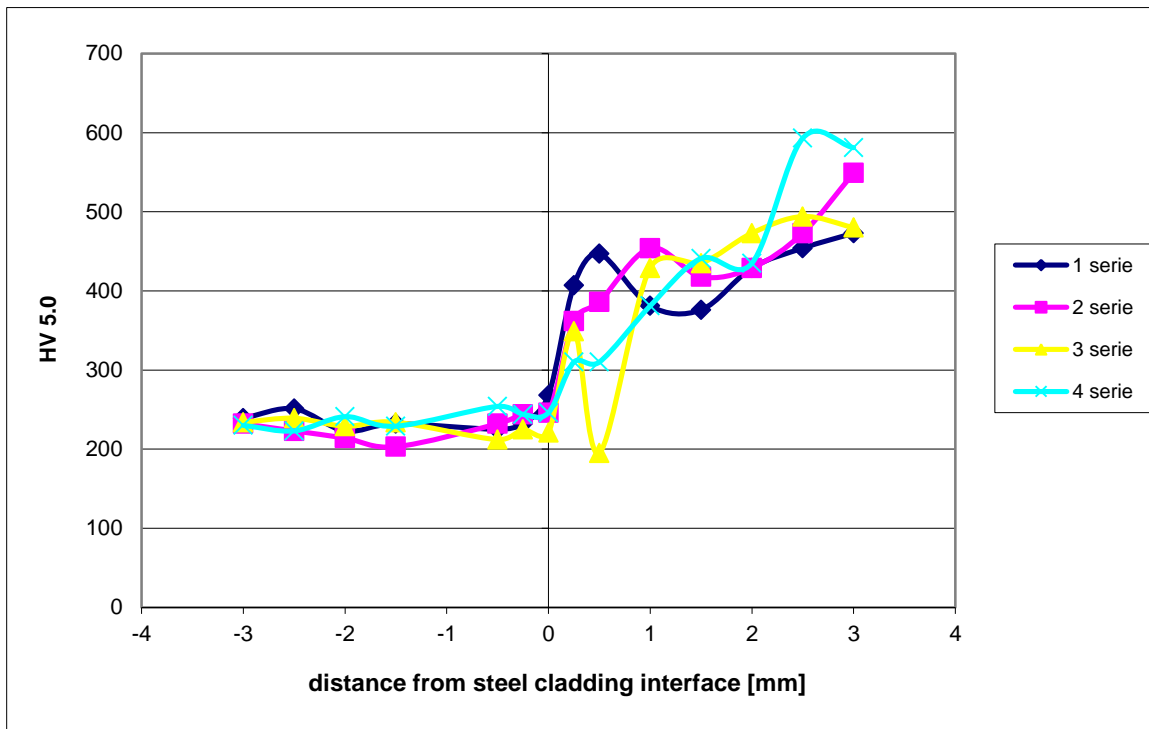
*Fig.11. Results of HV5 hardness measurements for face cladding and steel base of N valve after 2000 hours operation - 4 series*

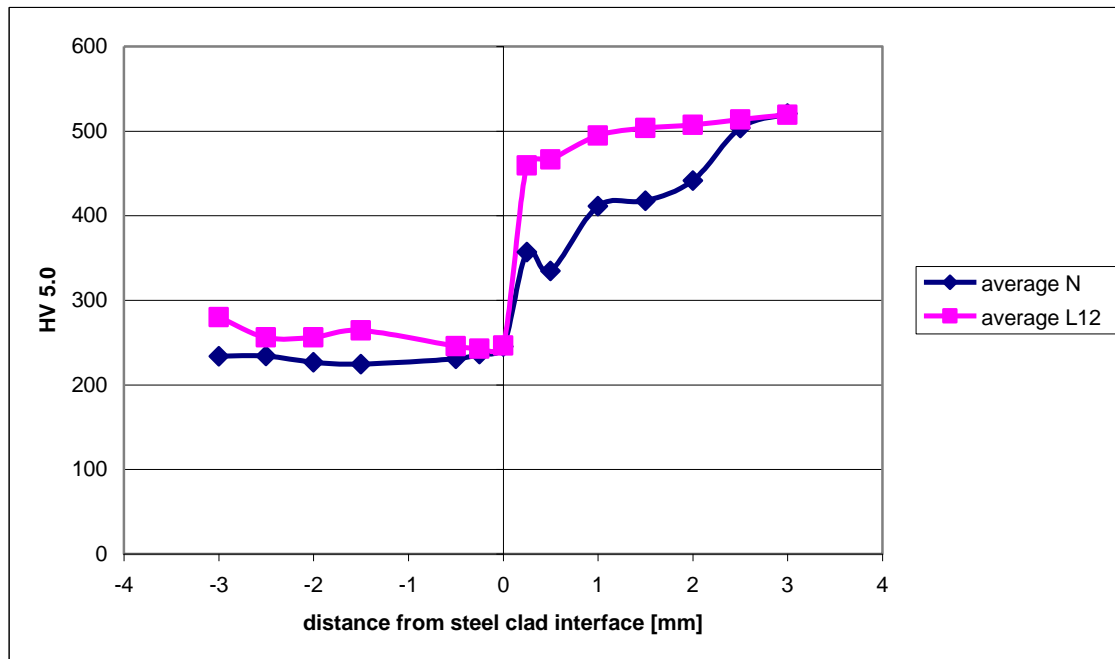
Fig.13. Comparison of average values of hardness of the faces claddings N i L12

- The cladding process provided both clad layers on the valve faces with a correct structure, typical for cladding process.
- The analysis showed that not every stellite type cobalt alloy can be used in harsh conditions that are observed at the valve outlet of the ship engine. The cladded layer made of the powder with higher amount of Ni proved to be less resistant for real exposure conditions.
- Differences in the chemical composition of alloys led to the creation of the layers of different hardness of N and L12 valve which could affect the durability of the faces
- It is also important to consider the possible mechanical factor i.e. - the valve is a grinding-in valve. This would imply irregular wear of the seat in the undamaged area of the N valve. Improper valve fitting in combination with imprecisely selected material led to premature valve failure
