Hanna Smoleńska<sup>1</sup>, Włodzimierz Kończewicz<sup>2</sup>

## **The impact of material selection on mechanical properties and durability of exhaust valve faces of a ship engine, after operation in real conditions**

Valves with faces covered with layers have been installed in the engine on the ship “Dar Młodzieży”. AL 20/24 engine has the following parameters: in-line engine, 8-cylinders; cylinder diameter 200 mm; piston stroke 240 mm; swept capacity 7540 cm<sup>3</sup>; nominal rotational speed 720/750 rev/min or 900/1000 rev/min; 136kW/Cyl.

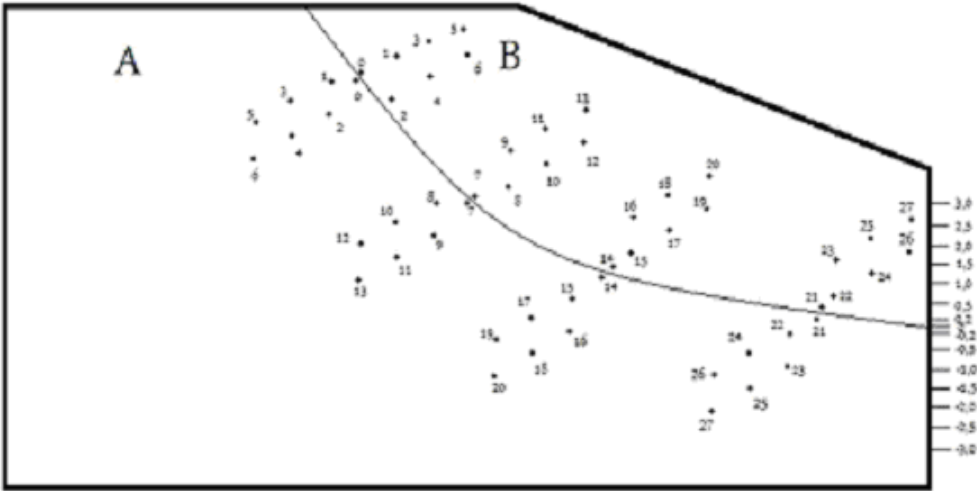
The hardness measurement in the cross-section of the cladding face layer after the operation period was carried out. Due to the technology of applying the layer, the hardness measurement was carried out according to developed scheme shown in fig. 8.

*Fig.8. Positions of hardness measurement points on the cross-section of the cladded layer and the substrate; a –steel base, B - cladding layer*

Due to the heterogeneous structure of the material four measurement series were made, the mean hardness value and the confidence interval were determined. The results are shown in fig. 9÷13.
